TAMF4-2016-019

June 2, 2016 Memo # 0019

SAFETY

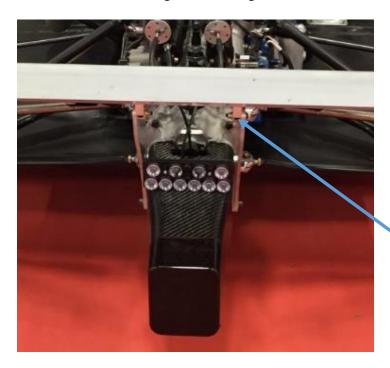
SCCA Pro has been advised by a team testing today that they suffered a rear wing issue resulting in the loss of the rear wing.

Vertical bolts into main-plane - check

Teams testing currently or imminently should take extra care in checking the rear wing assembly, taking particular care to check the bolts holding the mounting brackets to the lower main-plane – see picture below.
